SMT TROUBLE SHOOTING GUIDE

SMT TROUBLE SHOOTING OUTLINE

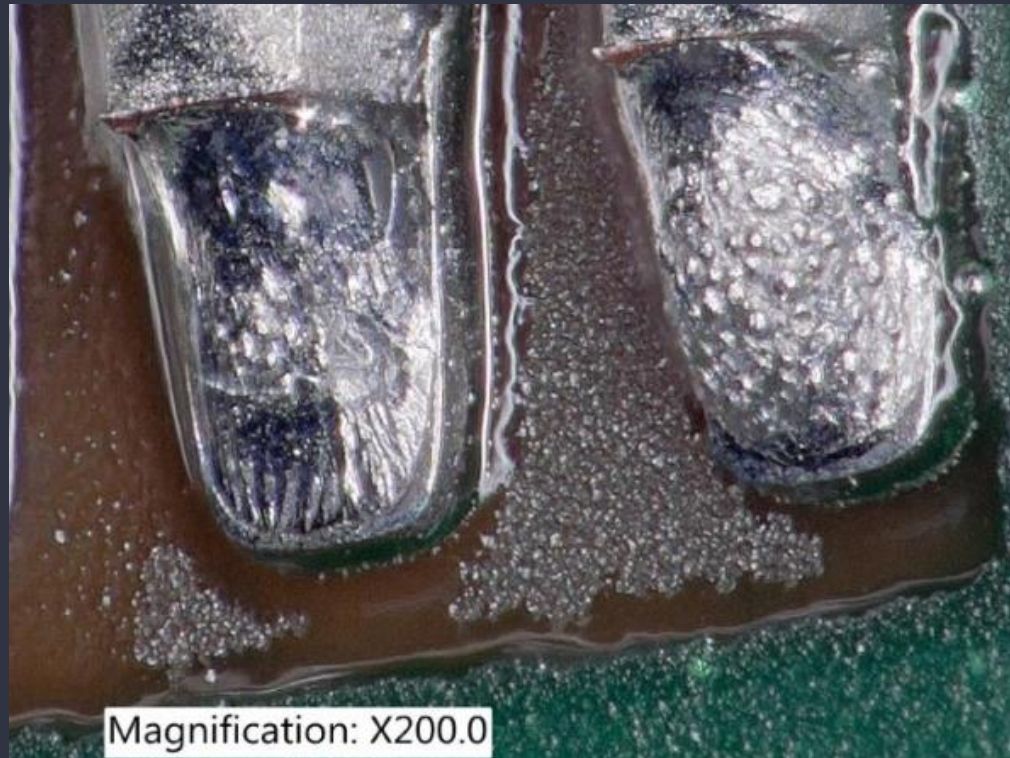
Definition: Grainy joints, also known as graping, refer to a solder joint defect where the solder appears rough and grainy, or like a bunch of grapes after reflow.

How to Recognize: Grainy joints can be visually identified by the distinct granular texture on the solder joint surface.

Problem	Cause	Solution
Oxidized solder particles	If solder particles within the paste are oxidized, they may not coalesce smoothly, leading to a grainy appearance.	Use fresh solder paste and ensure proper storage conditions to prevent oxidation. Consider a mild cleaning agent if oxidation is suspected.
Aggressive reflow profile	An overly aggressive reflow profile, especially during the ramp-up stage, can cause solder particles to reflow prematurely and individually. If the flux within the solder paste volatilizes too quickly, it can lead to graping.	Optimize the reflow profile to ensure a gradual and uniform melting of solder particles. In particular, adjust the soak and ramp-up stages, to allow for a more gradual flux volatilization.
Reflow in air vs nitrogen	Reflowing in air, especially for some solder paste formulations, can lead to increased oxidation and grainy joints.	Consider reflowing in a nitrogen atmosphere, especially for lead-free solder pastes that may be more susceptible to oxidation.
